APPENDIX B

**HISTORICAL MINERAL WATER SYSTEM
INFORMATION**

Soap Lake Mineral Water System Failure Report

By John Glassco & Steve Wellein for the City of Soap Lake

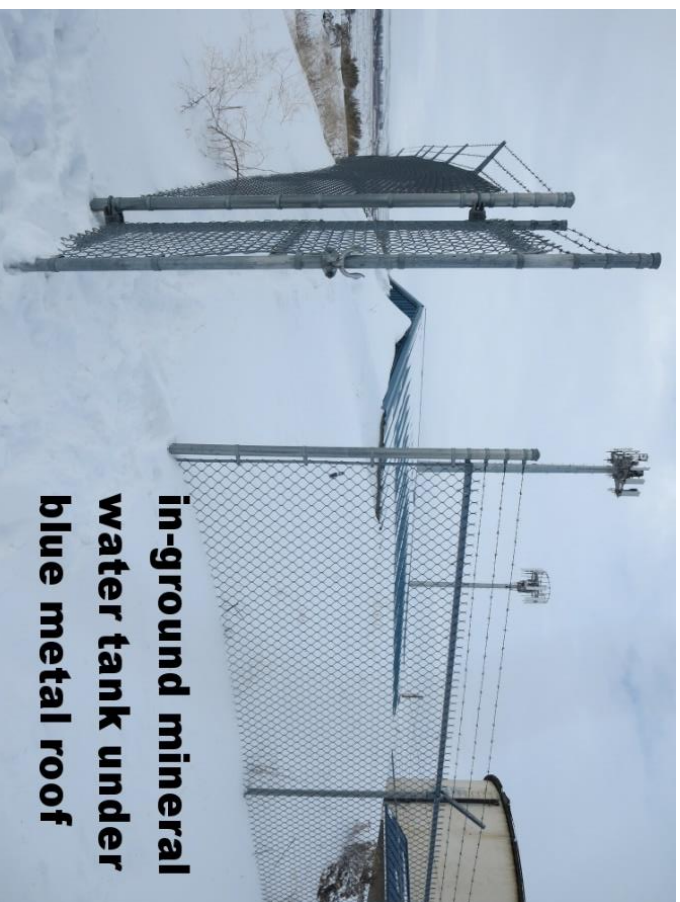
**in-ground mineral
water tank under
blue metal roof**

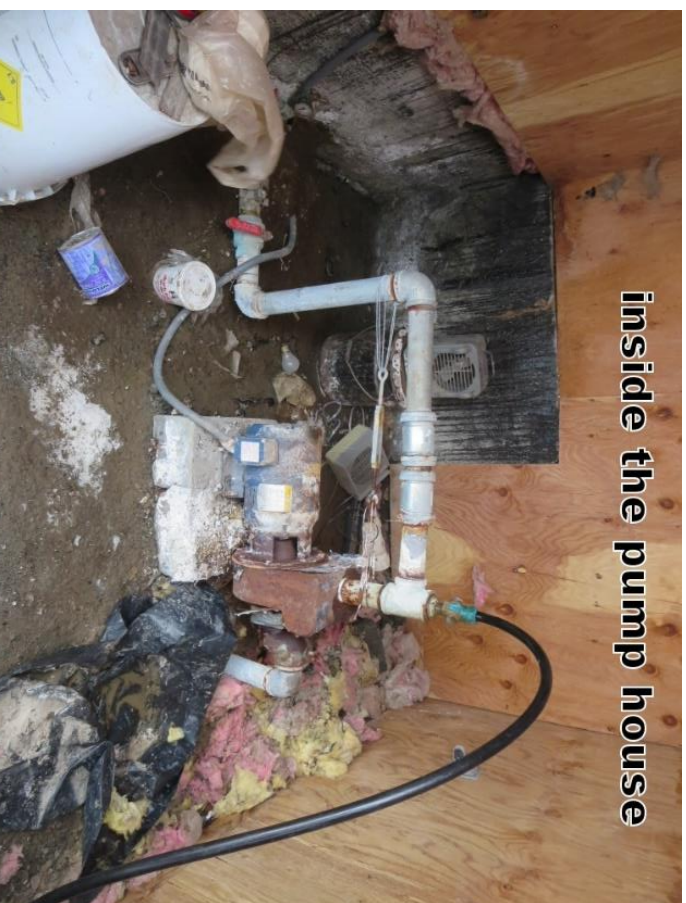
inside the pump house

1. The mineral water pumping system is obsolete. You can see from the picture of the inside of the pump house that even the concrete base of the pump is cracked placing the pump and the pump motor out of alignment stressing the bearings. The entire pumping setup needs replacement with a more robust and perhaps more powerful pump plus redundant equipment to ensure consistent and reliable operation.

In the short term, the replacement of the pump house and the suction line is necessary to ensure the reliable delivery of mineral water. This is an urgent problem requiring immediate attention. The estimate from a qualified practitioner, Kirk Youngers is included in the addendum. This estimate is for \$64,191.19. Given the neglect of the system, to us this seems reasonable and better than expected.

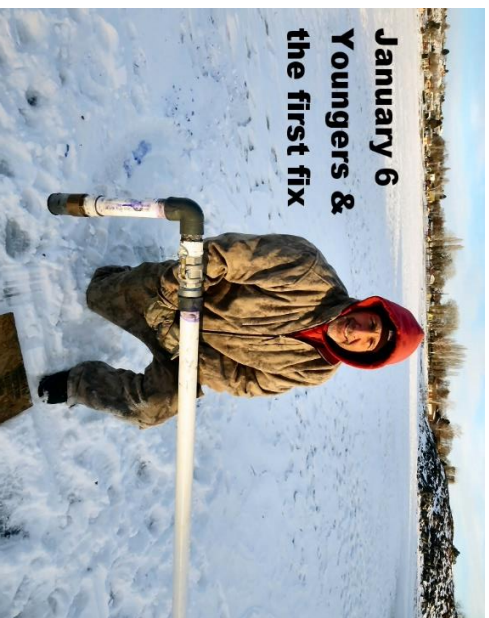
On January 6th, the suction line was rebuilt out onto the surface of the lake with an inlet stubbed through a hole cut in the ice. The pump and pump house had thawed by this time and the lake was sucking air when removed from the lake water.

**January 6
Youngers &
the first fix**
