### Memorandum

**Re:** Soap Lake Shoreline Jurisdiction Review for SMP Update

### Attachment 2 Aerial Photograph Mapping

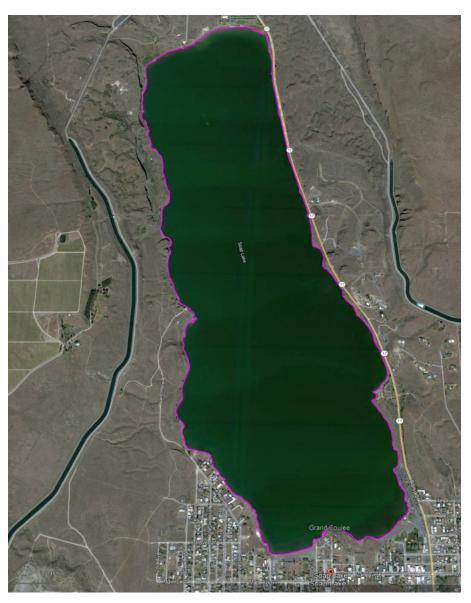
Overview

## Approximate extent of OHWM (pink line) based on aerial photo review in Google Earth (April 2021 photo)

For purposes of this memorandum, the consultant team reviewed aerial photographs in Google Earth for indications of the approximate OHWM location on Soap Lake (shown in Attachment 2). The OHWM location illustrated in Attachment 2 is based largely on clear topographic changes and the water level visible in the April 2021 Google Earth aerial photograph.<sup>2</sup>

As stated earlier, the U.S. Bureau of Reclamation maintains the water level in Soap Lake at 1078 feet MSL. This elevation is not yet depicted in Attachment 2 because as the consultant team is working with the U.S. Bureau of Reclamation to obtain the vertical datum to accurately depict the elevation location. We also hope to obtain a dataset of historical lake level fluctuation and will amend this

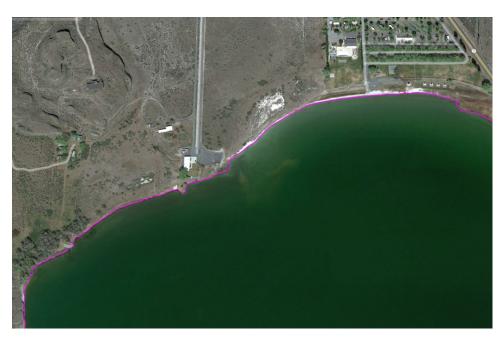
North end

## Approximate extent of OHWM (pink line) based on aerial photo review in Google Earth (April 2021 photo)
