APPENDIX B

**HISTORICAL MINERAL WATER SYSTEM
INFORMATION**

Soap Lake Mineral Water System Failure Report

By John Glassco & Steve Wellein for the City of Soap Lake

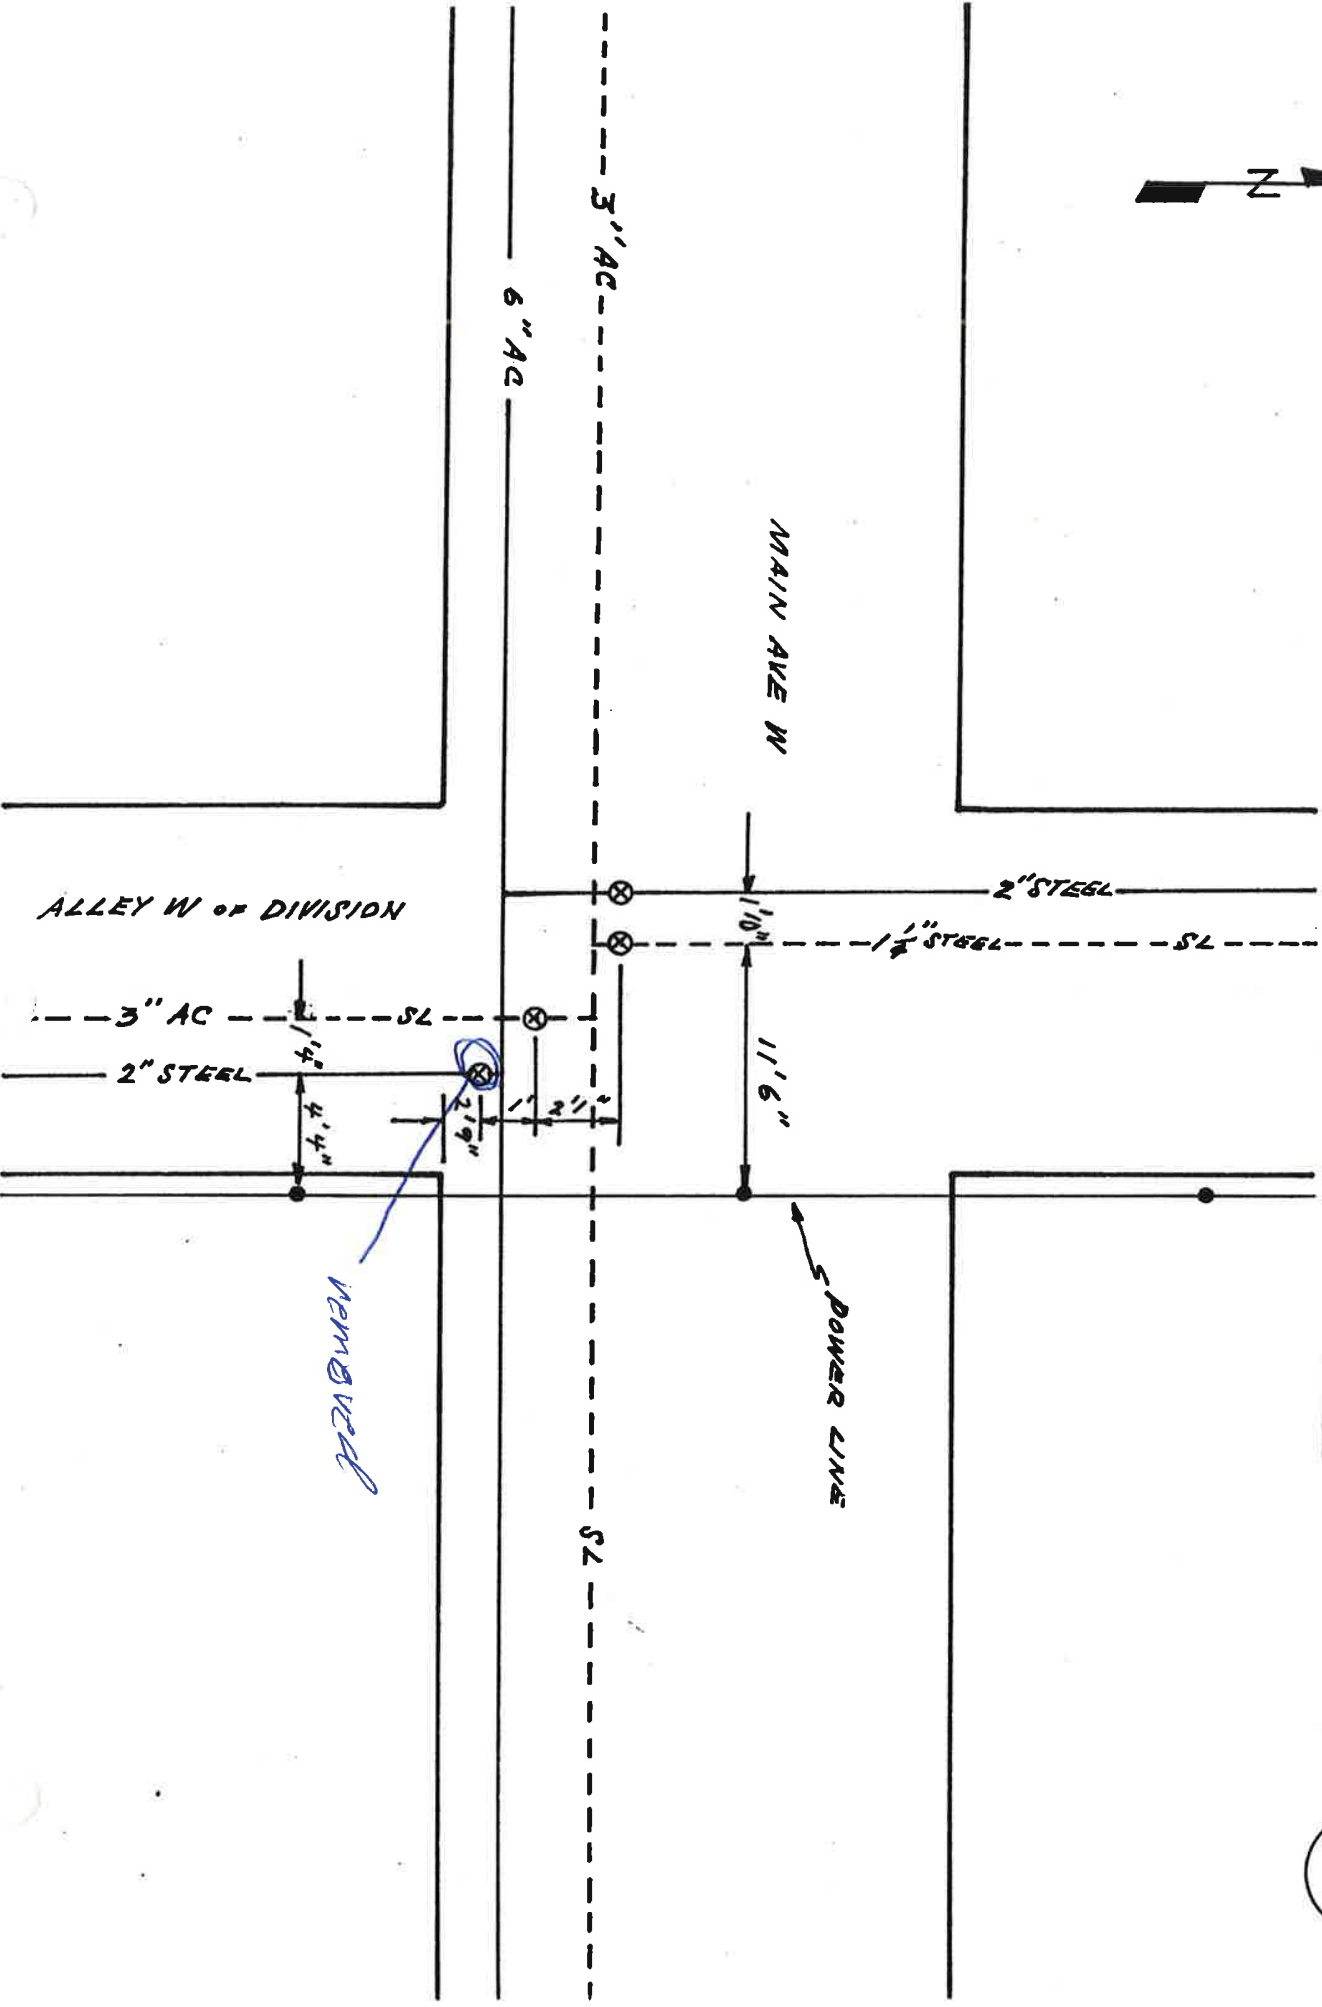
ALLEY W OF DIVISION

REMOVE

POWER LINE

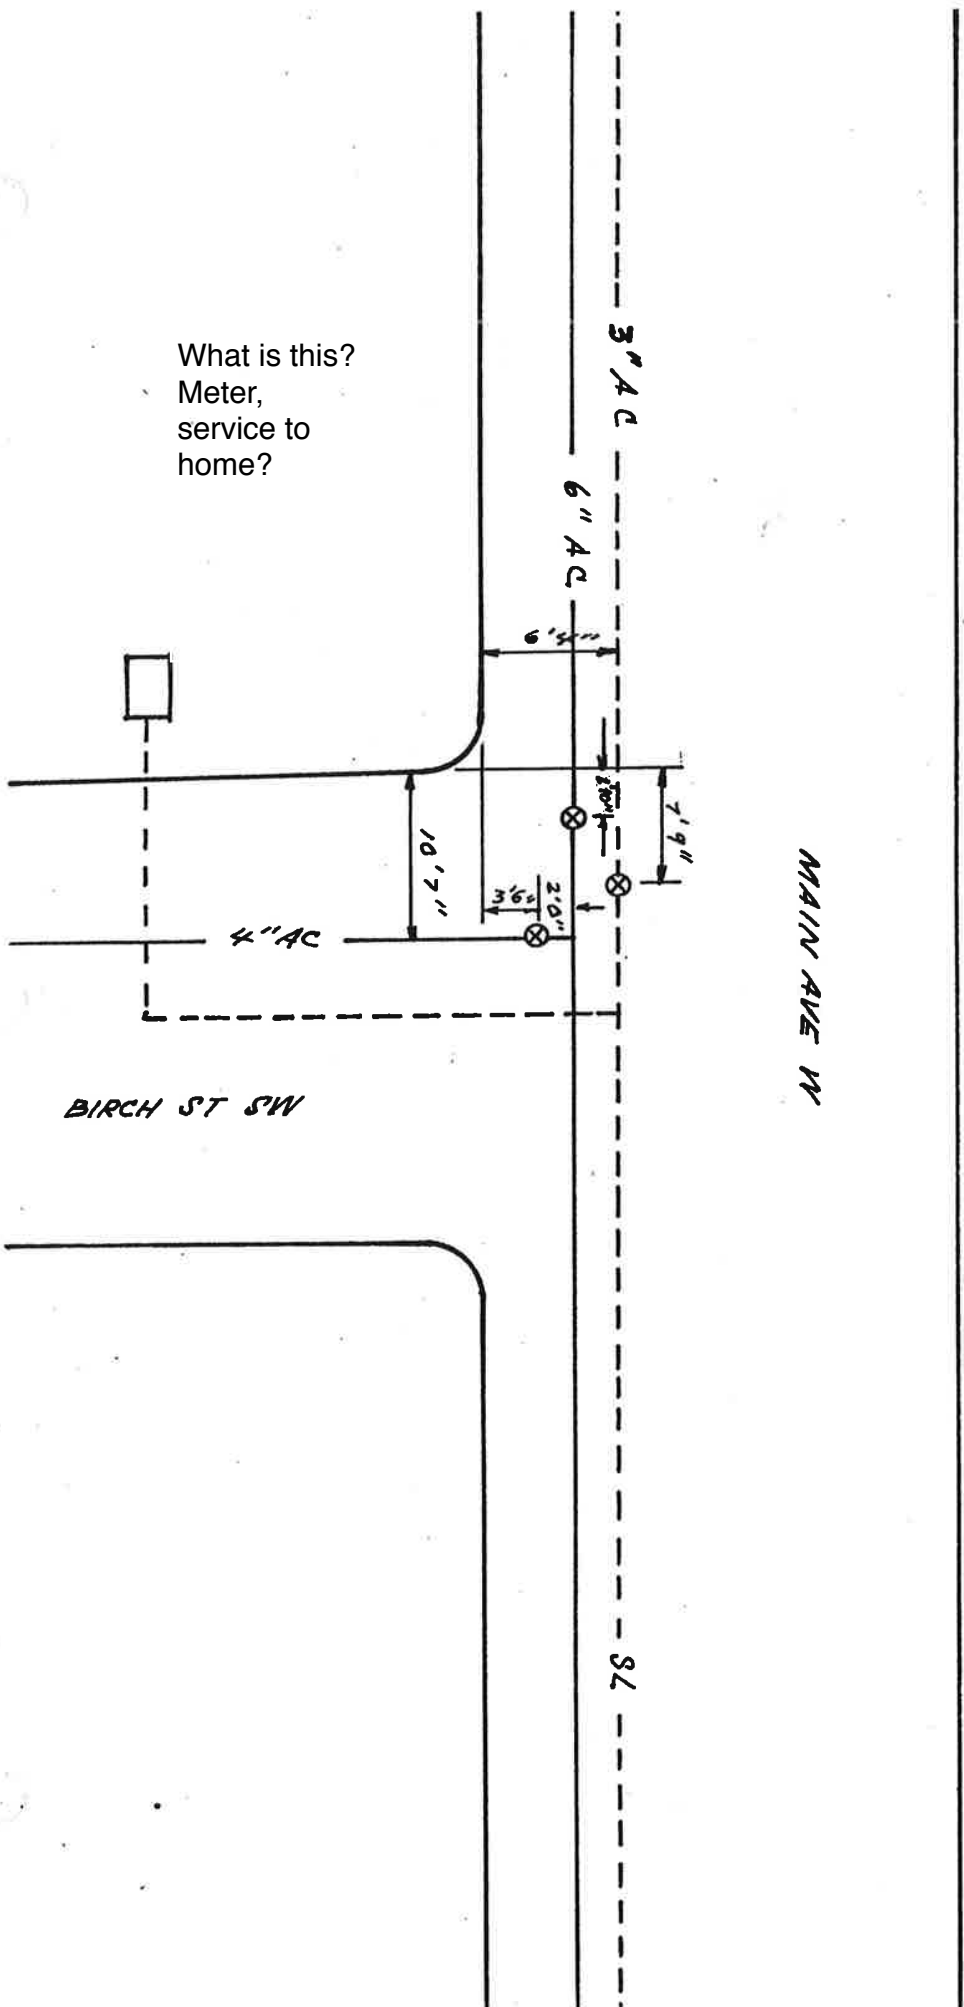
6

What is this?
Meter,
service to
home?

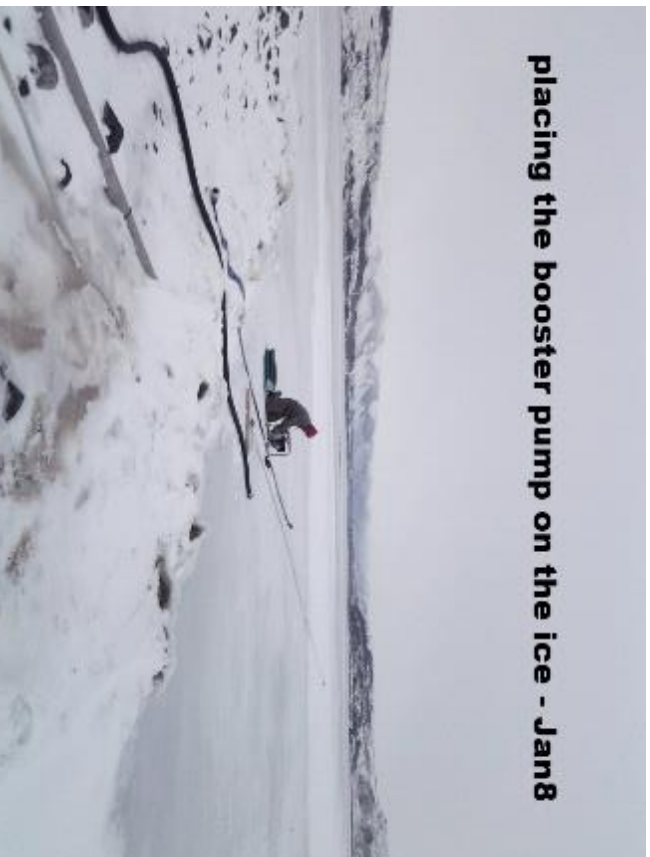
**January 7
total freeze**

placing the booster pump on the ice - Jan 8

That night the pump ran continuously, and the temperature dropped several degrees below zero. In the morning an inspection of the fresh water level in the tank showed no change. Returning to the pump house we discovered that the entire suction line had frozen solid and shattered. Apparently the old pump was too weak to move the water fast enough to prevent freezing.

On January 7th, materials were purchased to rebuild the suction line with the additional purchase of a portable 5 horsepower gasoline powered booster pump to be placed out on the ice to supply sufficient force to supplement the weak centrifugal electric pump.

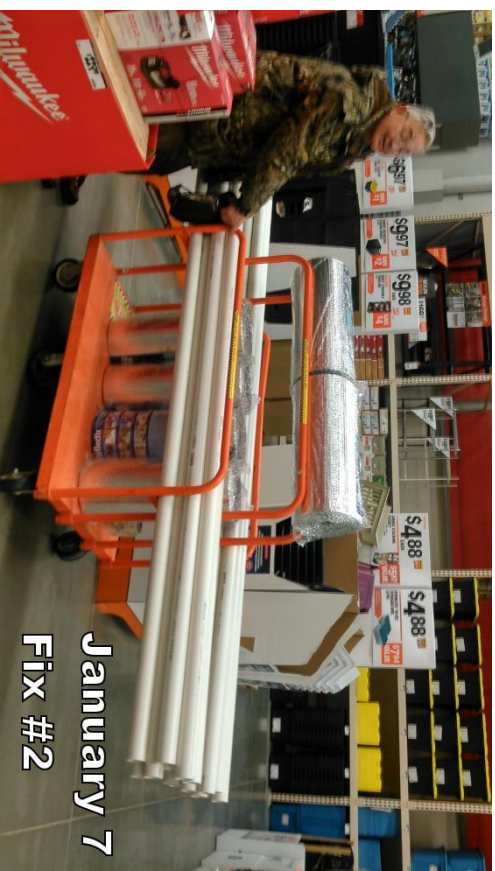
January 7
Fix #2

On January 9th, a kerosene turbine heater was purchased to direct a hot air blast to the base of the pump house. This setup was shrouded to keep out the cold air, and the base of the building was thawed completely. Chunks of ice exited the line onto the ice confirming that this was the location of a blockage in the suction line that probably was a major part of the problem to that point. The ball valve in the pump house was opened that afternoon to drain all of the fresh water out of the tank on the hill, through the transport line between the tank and the pump, and through the stationary pump and the suction line out onto the ice over the next 5 or so hours.

That night of the 9th, the system was primed, and both pumps were turned on. The night was again bitter cold and below zero, but the booster pump ran flawlessly through the night supplementing the stationary pump in the pump house. Although the booster pump with its small gas tank required fuel every two hours, by early morning, the elevation of mineral water in the tank reached its maximum level.

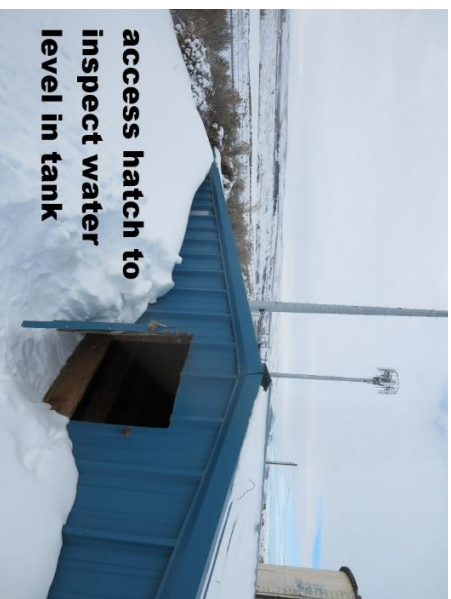
Inspection of the water level in the tank is measured from the bottom of the roof trusses to the surface elevation of the mineral water in the tank.

On January 10th at 9 AM, the elevation of water had reached to within 10 inches of the bottom cord of the trusses, the pumps were shut off, and the temporary setup was removed from the lake.

**access hatch to
inspect water
level in tank**
